United States Border Inspection Station
103 Cherry Street
Sumas
Whatcom County
Washington

HABS No. WA-182

HISTORIC AMERICAN BUILDINGS SURVEY

UNITED STATES BORDER INSPECTION STATION HABS No. WA-182

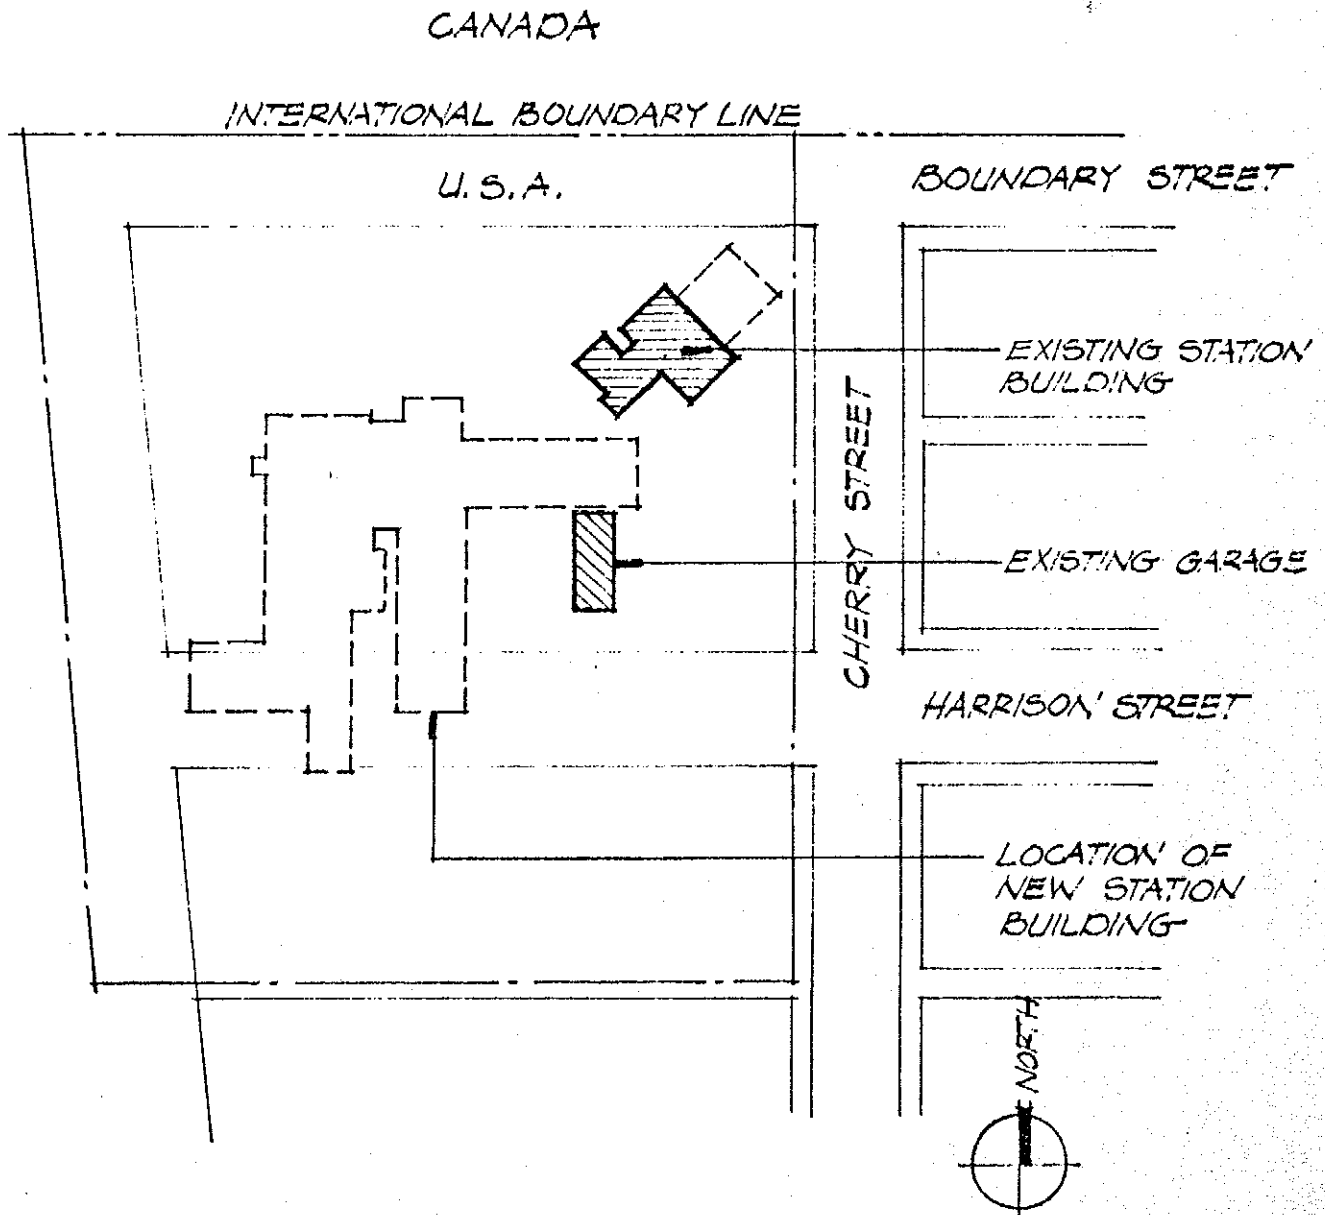
UNITED STATES BORDER INSPECTION STATION
HABS No. WA-182 (Page 17)

SITE MAP

1. Overall dimensions: The building faces northeast (at a 45 degree angle to the city street grid) and measures 55 feet by 34 feet deep. Across the front was a canopy measuring 40 feet by 40 feet which was replaced in 1970. The building is two stories with a full basement.
